**Flood Control Project Maintenance
Levee Inspections**

Fall 2009 Levee Maintenance Deficiency Summary Report

San Joaquin River Basin

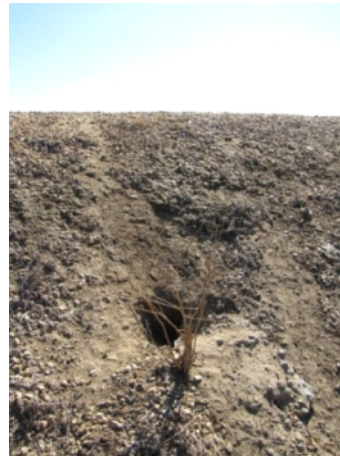
dpesaven_20091102_377.jpg

Levee Mile Report Line	61
Start Levee Mile	5.32
End Levee Mile	5.32
Location	Land Side
Category	Earthen Levee
Item	Animal Control

View of a rodent hole in the landward slope.

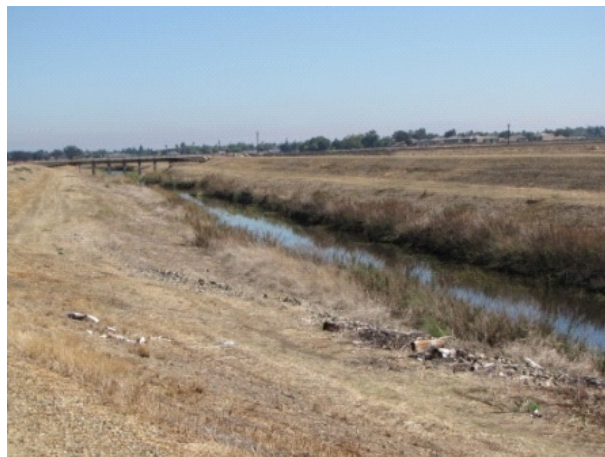
dpesaven_20091102_378.jpg

Levee Mile Report Line	62
Start Levee Mile	5.59
End Levee Mile	5.59
Location	Water Side
Category	Earthen Levee
Item	Encroachments

View of prunings, debris, and trash on the waterward slope looking upstream.

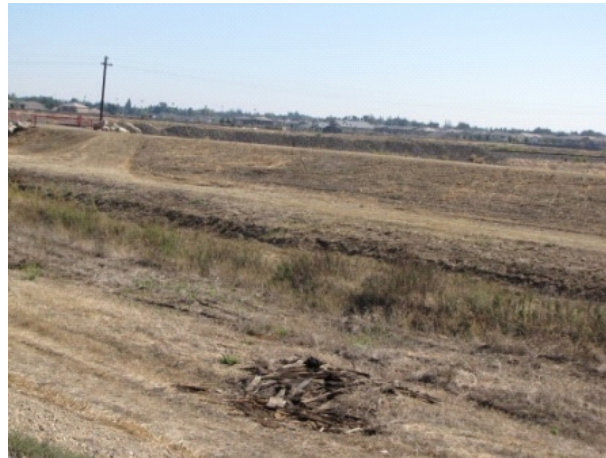
dpesaven_20091102_379.jpg

View of wood debris on the waterward slope.

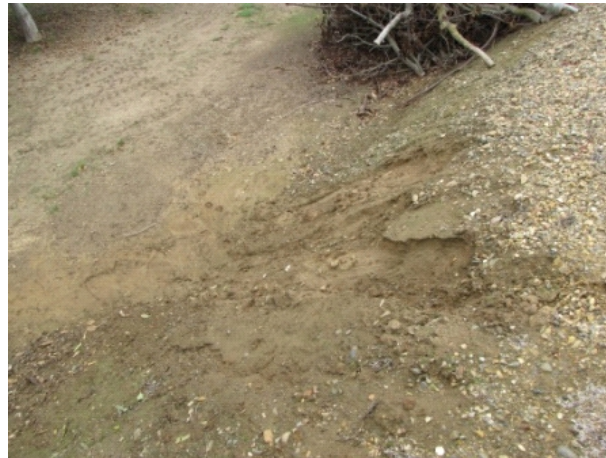
dpesaven_20091102_382.jpg

View of erosion occurring on the landward slope.

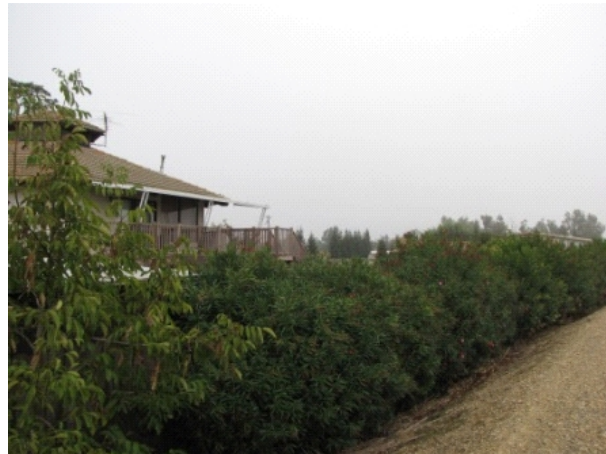
dpesaven_20091102_383.jpg

Levee Mile Report Line	79
Start Levee Mile	10.38
End Levee Mile	10.39
Location	Land Side
Category	Earthen Levee
Item	Encroachments

View of landscaping along the landward slope and toe looking upstream.

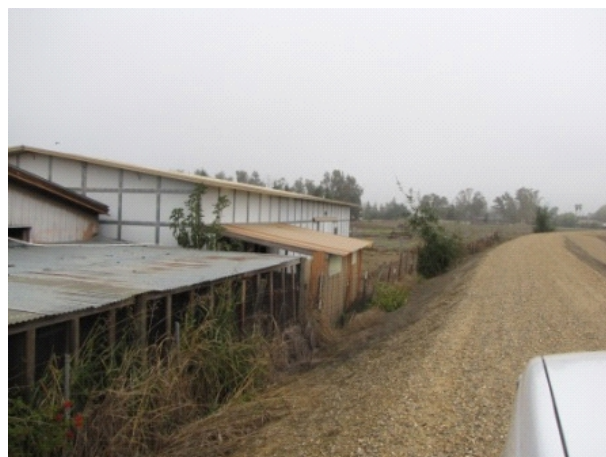
dpesaven_20091102_384.jpg

Levee Mile Report Line	80
Start Levee Mile	10.39
End Levee Mile	10.62
Location	Land Side
Category	Earthen Levee
Item	Encroachments

View of a metal fence and structure adjacent to the landward toe looking upstream.

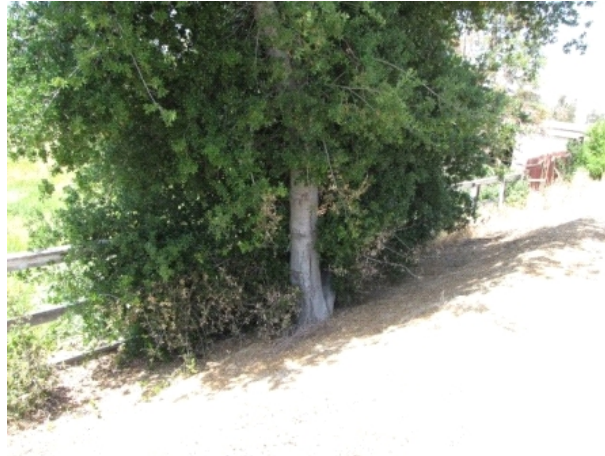
Levee Mile Report Line	81
Start Levee Mile	10.42
End Levee Mile	10.42
Location	Land Side
Category	Earthen Levee
Item	Trim / Thin Trees
Trim tree to allow for visibility of landward levee slope.	
dpesaven_20091002_68.jpg

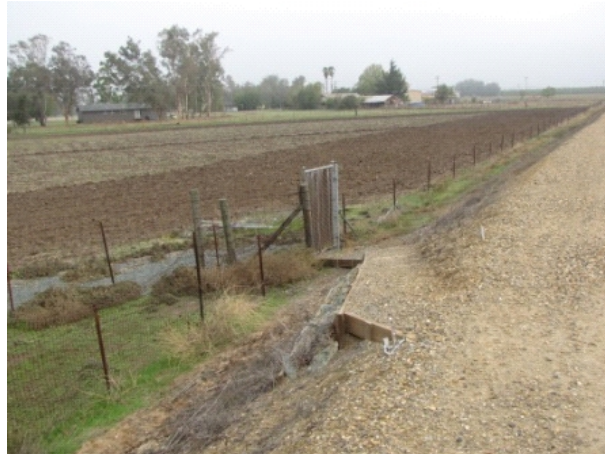
Levee Mile Report Line	83
Start Levee Mile	10.49
End Levee Mile	10.49
Location	Land Side
Category	Earthen Levee
Item	Encroachments
View of a ramp built into the landward slope looking upstream.	
dpesaven_20091102_385.jpg

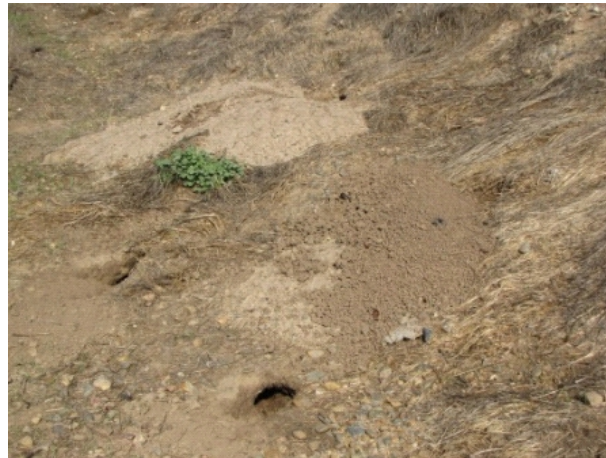
View of rodent holes in the landward slope.

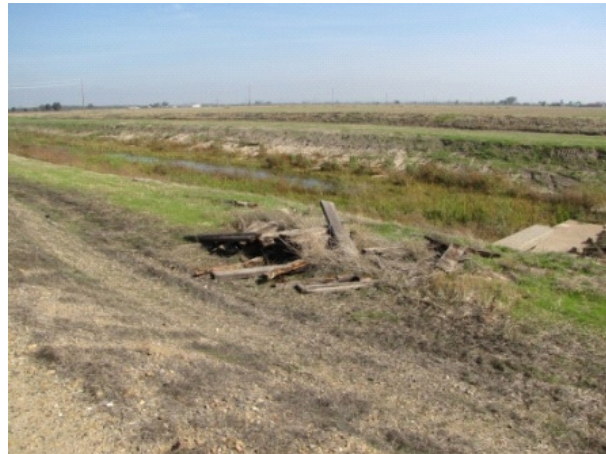
Levee Mile Report Line	87
Start Levee Mile	13.33
End Levee Mile	13.33
Location	Water Side
Category	Earthen Levee
Item	Encroachments

View of debris from the flapboard dam on the waterward slope.

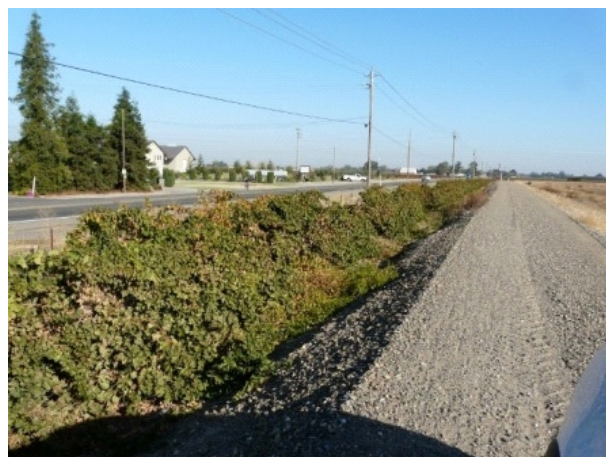
Levee Mile Report Line	88
Start Levee Mile	13.39
End Levee Mile	13.51
Location	Land Side
Category	Earthen Levee
Item	Encroachments

Grape vines within 10' from landside toe of levee from LM 13.39 to 13.51.

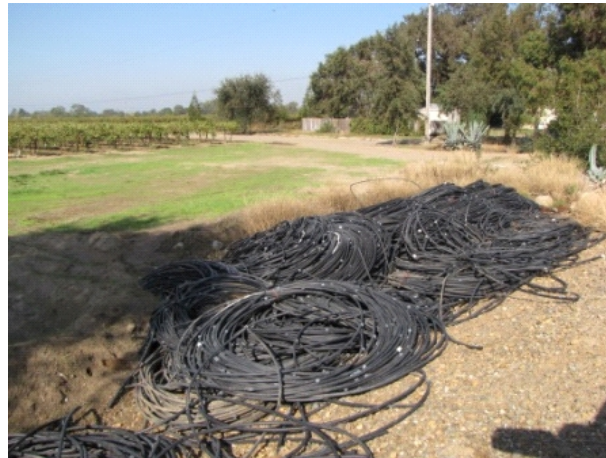
View of irrigation pipe on the landward slope.

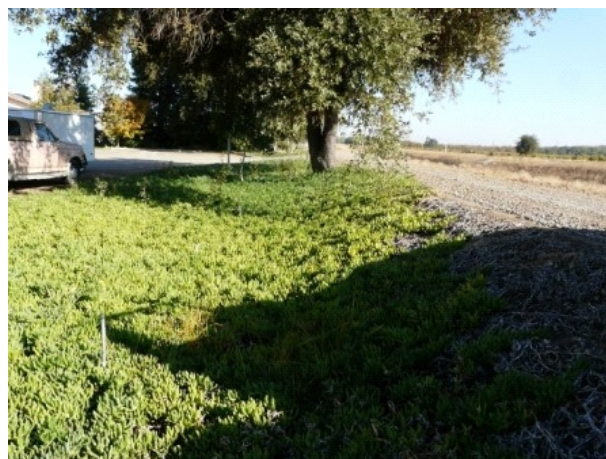
Levee Mile Report Line	92
Start Levee Mile	14.09
End Levee Mile	14.13
Location	Land Side
Category	Earthen Levee
Item	Encroachments

Landscaping on landside of levee from LM 14.09 to LM 14.13.

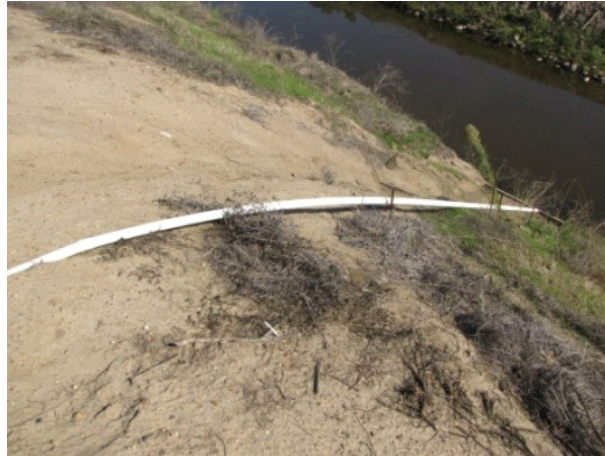
View of a pipe a landowner placed in the access road and waterward slope to pump water from the channel to irrigate their garden.

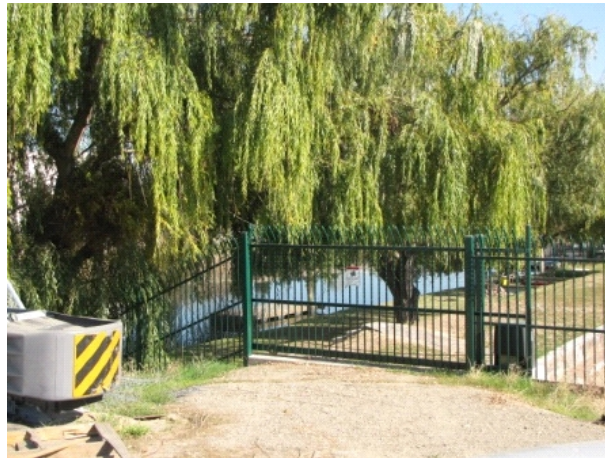
View of a open fence and gate across the crown at the current start of the unit looking upstream. Limited access has been provided.

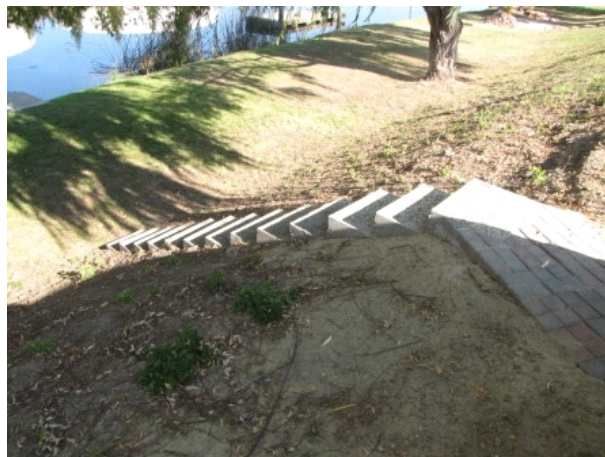
Levee Mile Report Line	2
Start Levee Mile	0.78
End Levee Mile	0.78
Location	Water Side
Category	Earthen Levee
Item	Encroachments

View of steps on the waterward slope of the levee looking upstream.

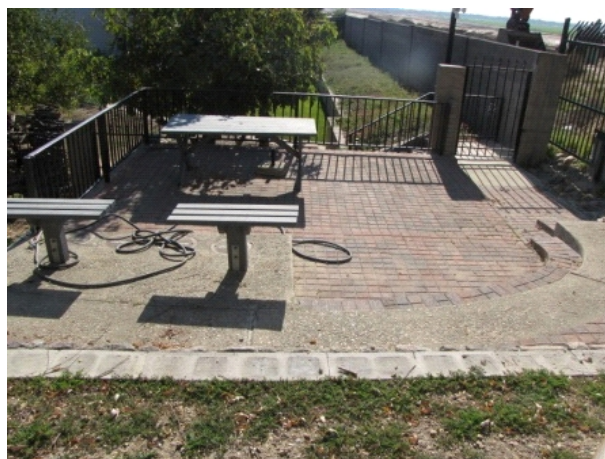
Levee Mile Report Line	3
Start Levee Mile	0.78
End Levee Mile	0.79
Location	Land Side
Category	Earthen Levee
Item	Encroachments

View of a patio with table, benches, and irrigation on the landward side of the levee.

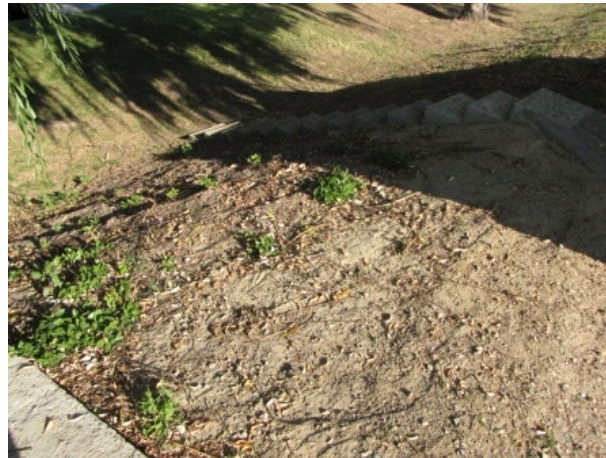
View of landscaping and irrigation on the waterward slope.

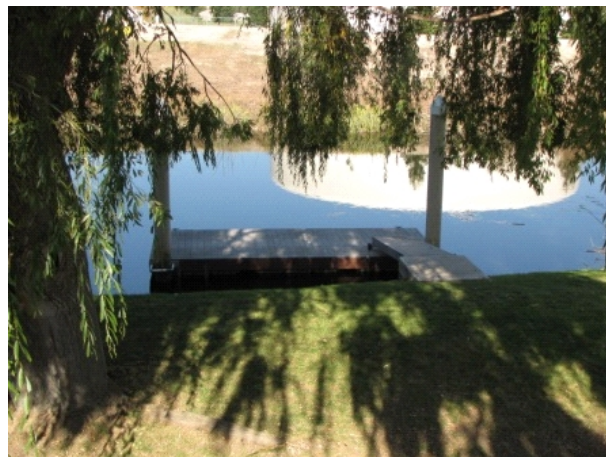
Levee Mile Report Line	5
Start Levee Mile	0.79
End Levee Mile	0.79
Location	Water Side
Category	Earthen Levee
Item	Encroachments

View of a dock off the waterward berm.

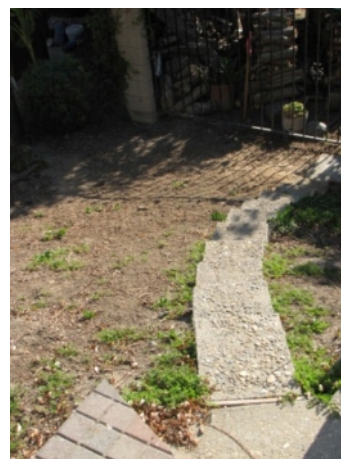
Levee Mile Report Line	6
Start Levee Mile	0.79
End Levee Mile	0.79
Location	Land Side
Category	Earthen Levee
Item	Encroachments

View of steps on the landward slope of the levee.

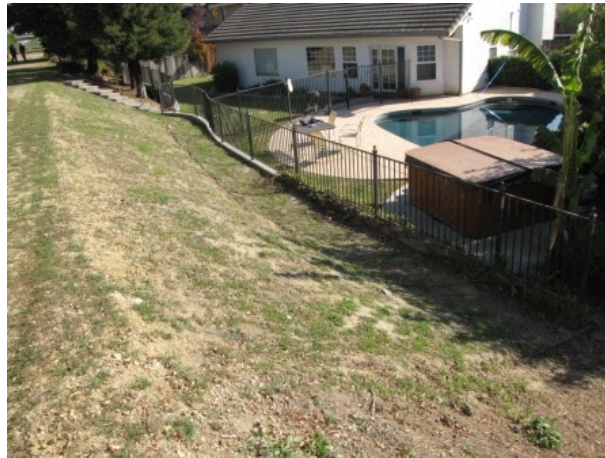
View of a fence on top of a retaining wall in the landward toe of the levee. Some landscaping and irrigation are also present.

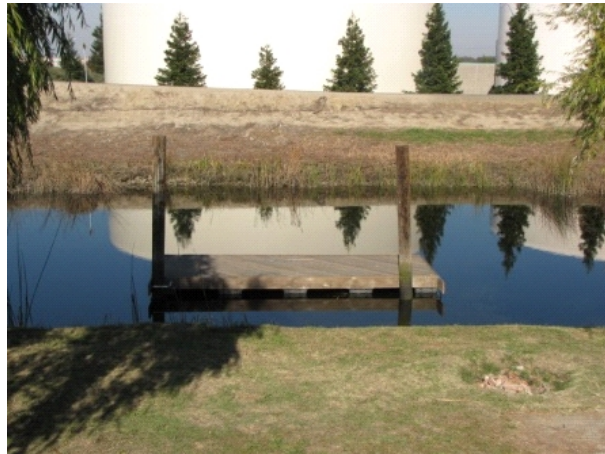
Levee Mile Report Line	8
Start Levee Mile	0.80
End Levee Mile	0.80
Location	Water Side
Category	Earthen Levee
Item	Encroachments

View of a dock off the waterward side of the berm.

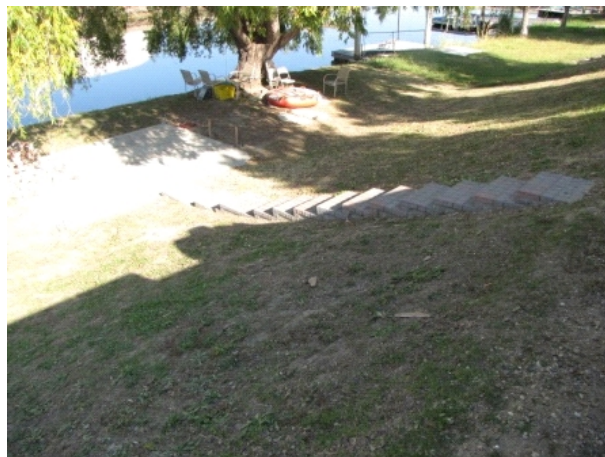
Levee Mile Report Line	9
Start Levee Mile	0.80
End Levee Mile	0.80
Location	Water Side
Category	Earthen Levee
Item	Encroachments

View of stairs and patio on the waterward slope and berm looking upstream.

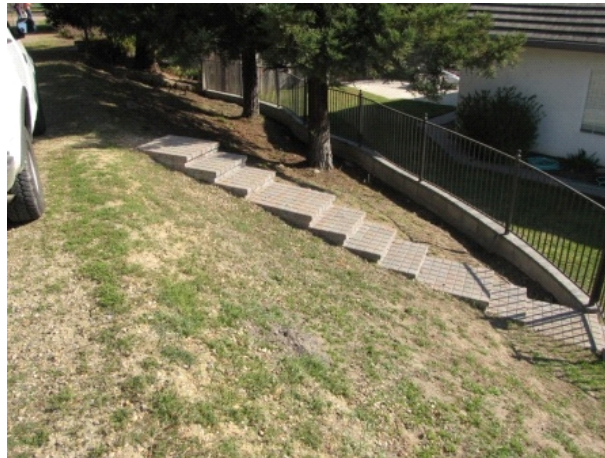
View of steps on the landward slope looking upstream.

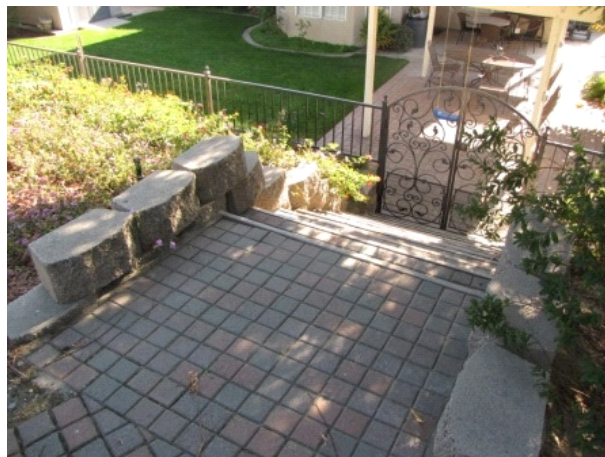
Levee Mile Report Line	11
Start Levee Mile	0.81
End Levee Mile	0.81
Location	Land Side
Category	Earthen Levee
Item	Encroachments

View of steps on the landward slope.

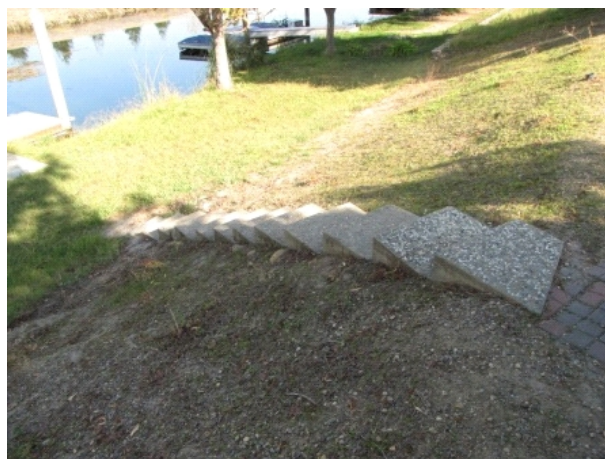
Levee Mile Report Line	12
Start Levee Mile	0.81
End Levee Mile	0.81
Location	Water Side
Category	Earthen Levee
Item	Encroachments

View of steps on the waterward slope looking upstream.

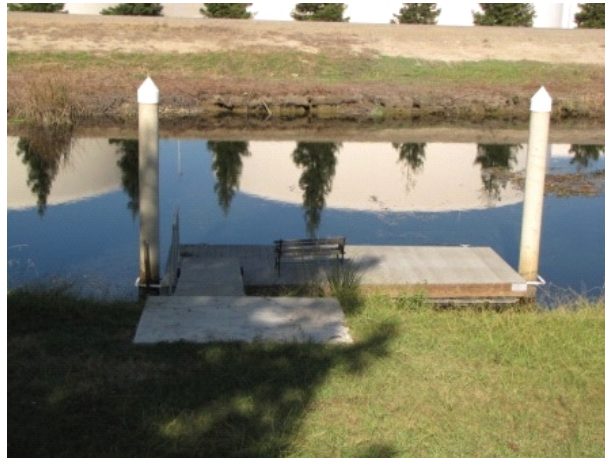
View of a dock on the waterward side of the berm.

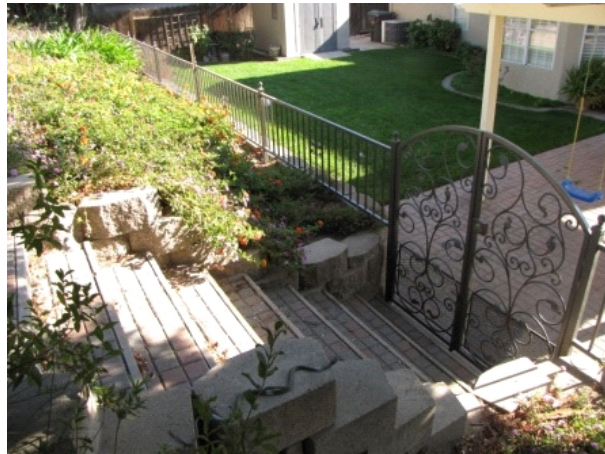
Levee Mile Report Line	14
Start Levee Mile	0.81
End Levee Mile	0.82
Location	Land Side
Category	Earthen Levee
Item	Encroachments

View of a open fence on a retaining wall in the landward toe of the levee looking upstream.

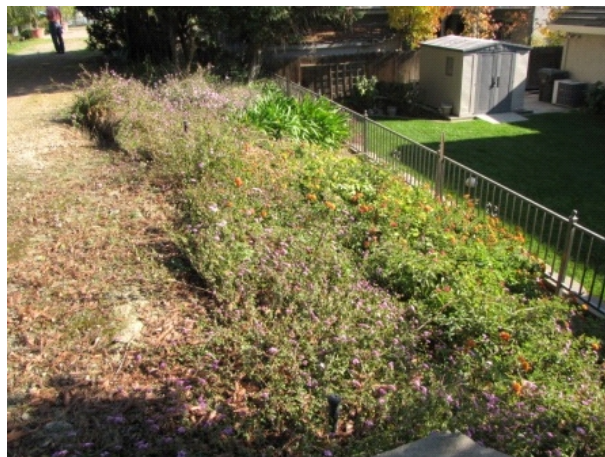
Levee Mile Report Line	15
Start Levee Mile	0.81
End Levee Mile	0.82
Location	Land Side
Category	Earthen Levee
Item	Encroachments

View of landscaping obstructing visibility and access and irrigation along the landward slope looking upstream.

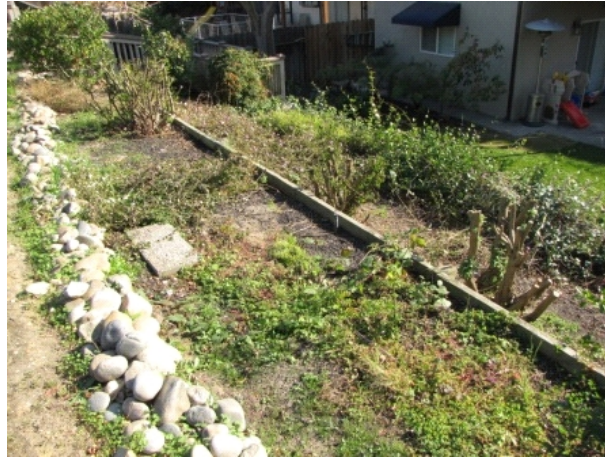
View of landscaping and irrigation along the landward slope looking upstream.

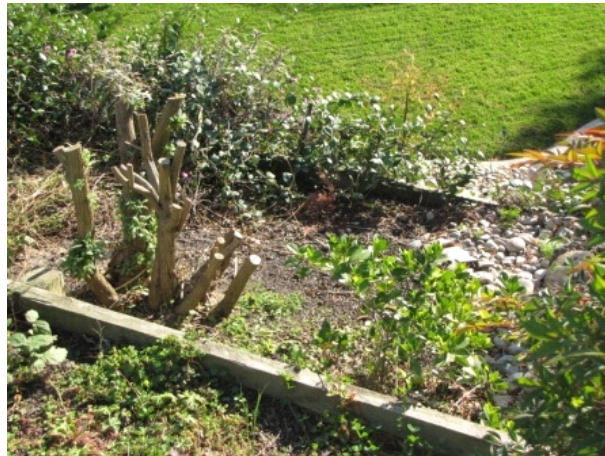
Levee Mile Report Line	17
Start Levee Mile	0.82
End Levee Mile	0.83
Location	Land Side
Category	Earthen Levee
Item	Encroachments

View of wood retaining walls created landscaping terraces.

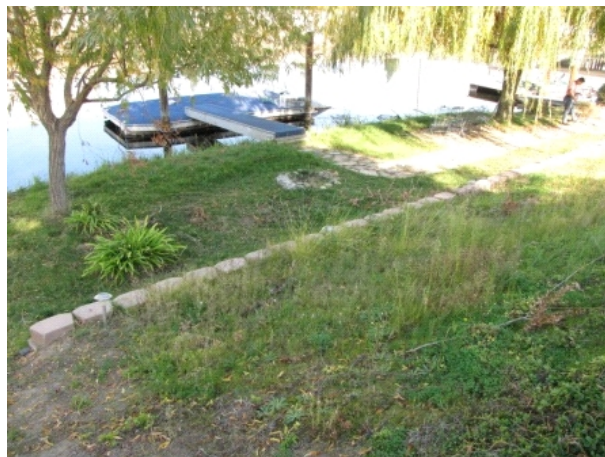
Levee Mile Report Line	18
Start Levee Mile	0.82
End Levee Mile	0.83
Location	Water Side
Category	Earthen Levee
Item	Encroachments

View of a retaining wall with electrical in the waterward toe looking upstream.

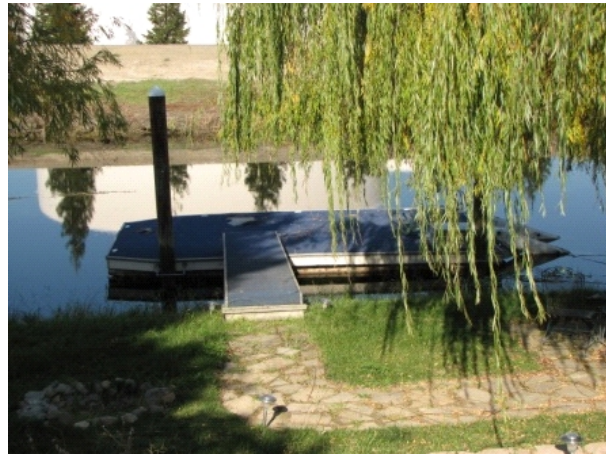
View of a dock and pathway on the waterward side of the berm.

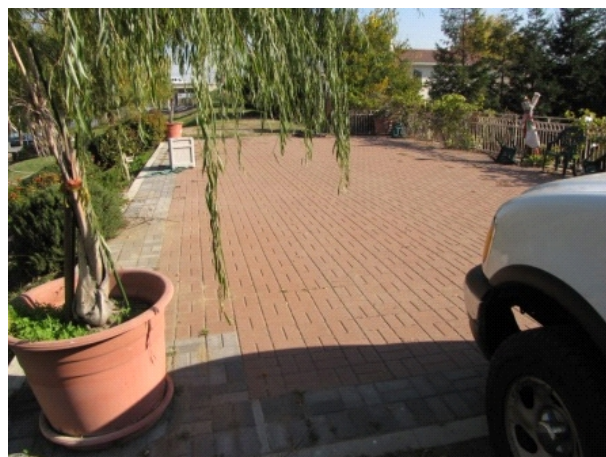
Levee Mile Report Line	21
Start Levee Mile	0.83
End Levee Mile	0.84
Location	Crown
Category	Earthen Levee
Item	Encroachments

View of pavers placed on the crown of the levee looking upstream. Potted landscaping and irrigation can also be seen.

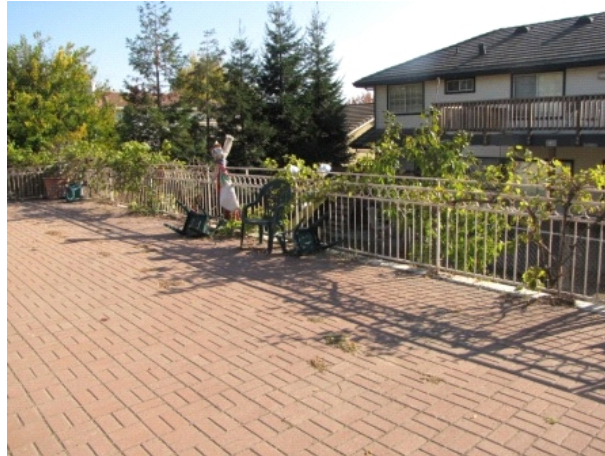
View of a fence on top of a large retaining wall in the landward slope looking upstream. Landscaping is growing along the fence.

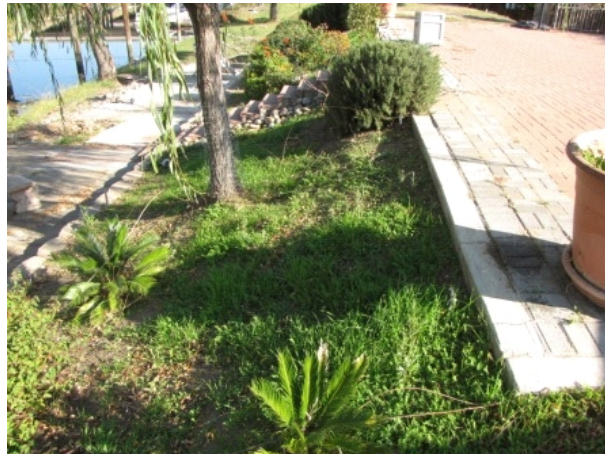
Levee Mile Report Line	23
Start Levee Mile	0.83
End Levee Mile	0.84
Location	Water Side
Category	Earthen Levee
Item	Encroachments

View of landscaping and irrigation on the waterward slope looking upstream.

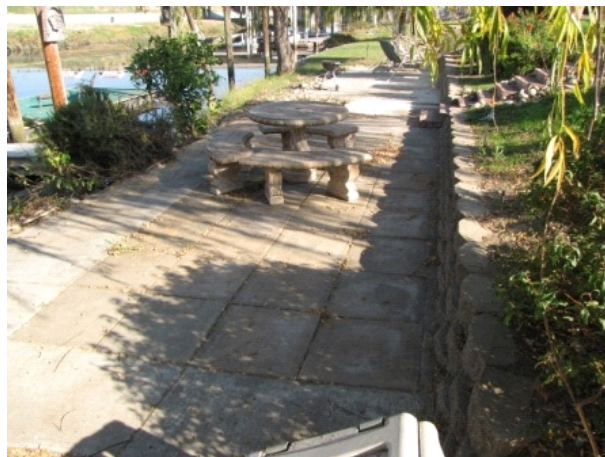
Levee Mile Report Line	24
Start Levee Mile	0.83
End Levee Mile	0.84
Location	Water Side
Category	Earthen Levee
Item	Encroachments

View of a retaining wall and patio with furniture in the waterward toe an berm looking upstream.

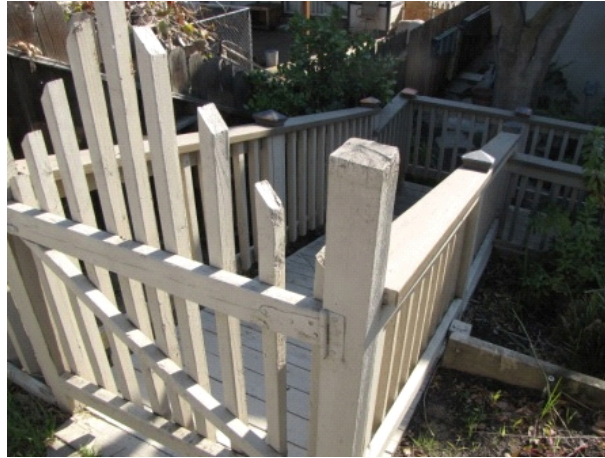
View of a ramp and steps on the landward slope.

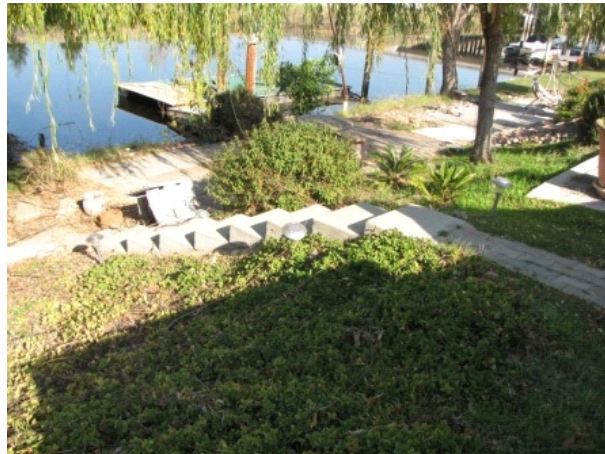
Levee Mile Report Line	26
Start Levee Mile	0.83
End Levee Mile	0.83
Location	Water Side
Category	Earthen Levee
Item	Encroachments

View of steps on the waterward slope looking upstream.

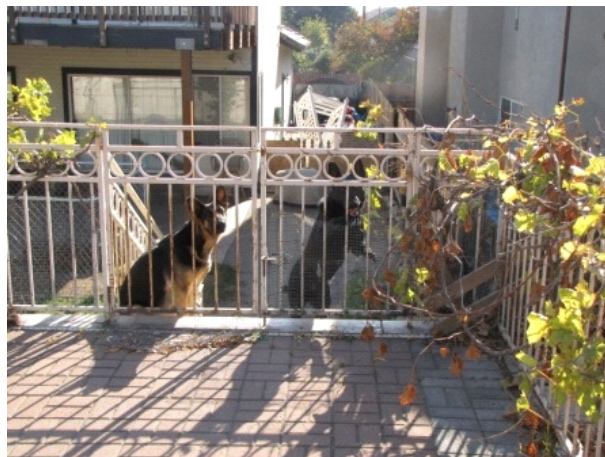
Levee Mile Report Line	27
Start Levee Mile	0.83
End Levee Mile	0.83
Location	Land Side
Category	Earthen Levee
Item	Encroachments

View of steps on the landward slope and dogs preventing a closer inspection.

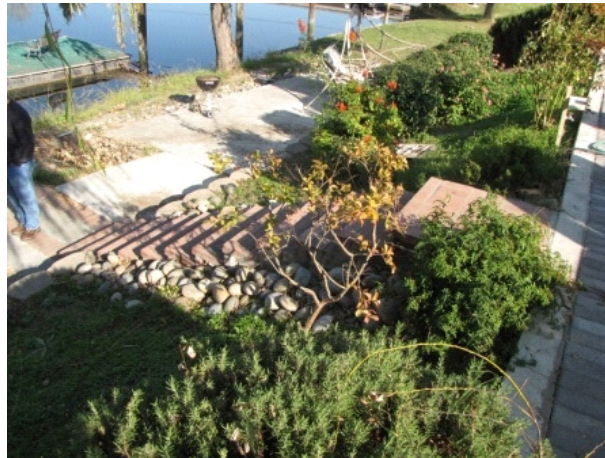
View of steps on the waterward slope of the levee looking upstream.

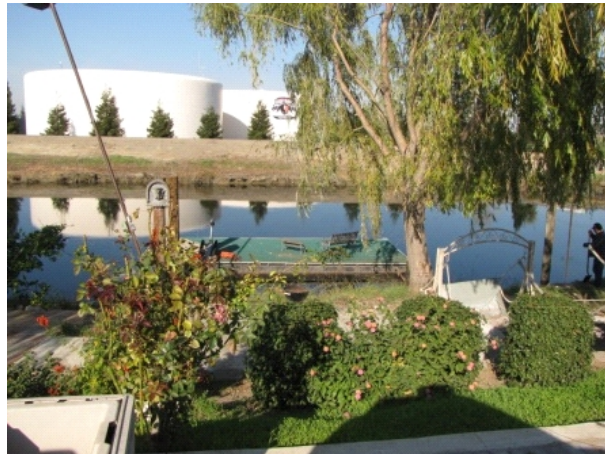
Levee Mile Report Line	29
Start Levee Mile	0.84
End Levee Mile	0.84
Location	Water Side
Category	Earthen Levee
Item	Encroachments

View of a dock on the waterward side of the berm.

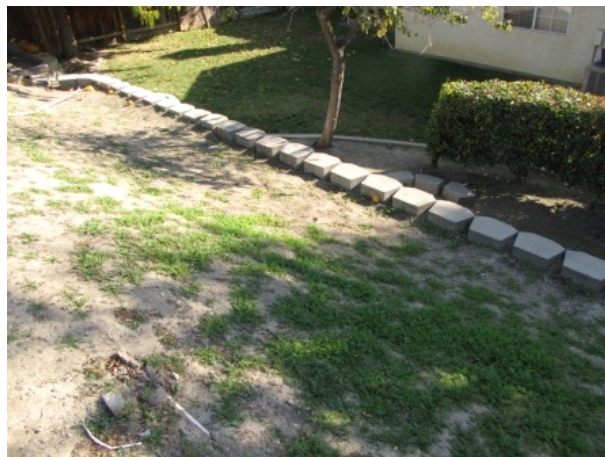
Levee Mile Report Line	30
Start Levee Mile	0.84
End Levee Mile	0.85
Location	Land Side
Category	Earthen Levee
Item	Encroachments

View of a retaining wall in the landward slope.

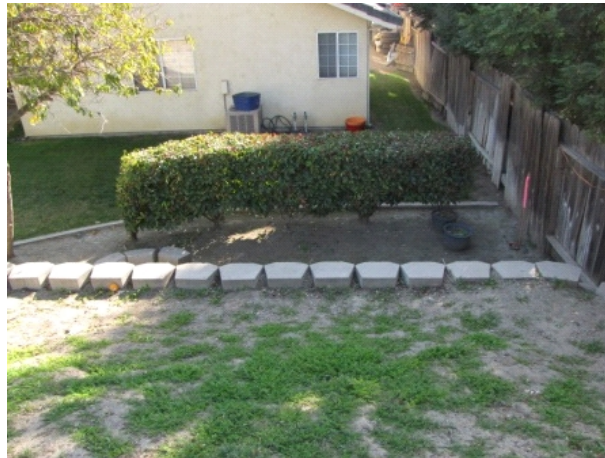
View of shrubs obstructing visibility at the landward toe.

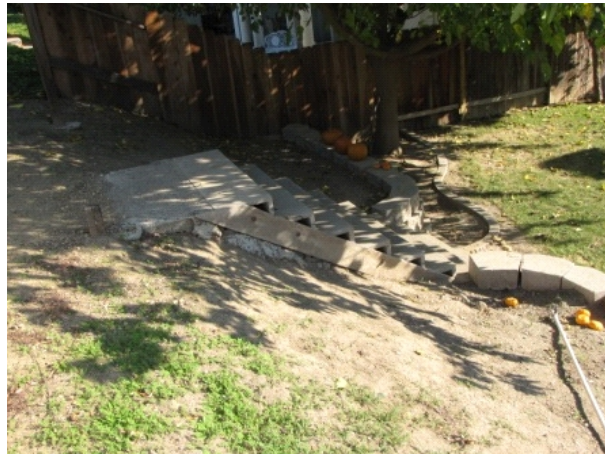
Levee Mile Report Line	32
Start Levee Mile	0.85
End Levee Mile	0.85
Location	Land Side
Category	Earthen Levee
Item	Encroachments

View of steps on the landward slope looking upstream.

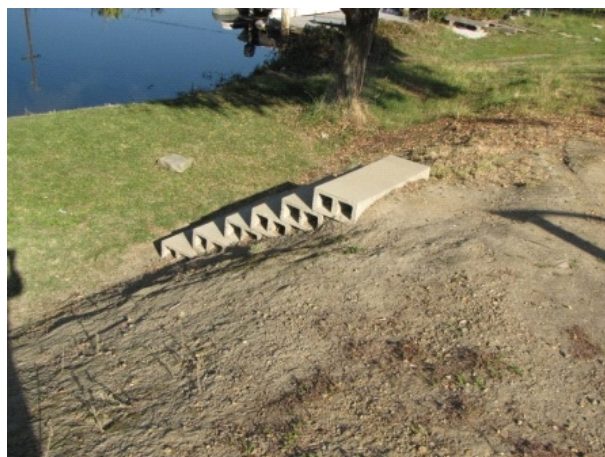
Levee Mile Report Line	33
Start Levee Mile	0.85
End Levee Mile	0.85
Location	Water Side
Category	Earthen Levee
Item	Encroachments

View of steps on the waterward slope looking upstream.

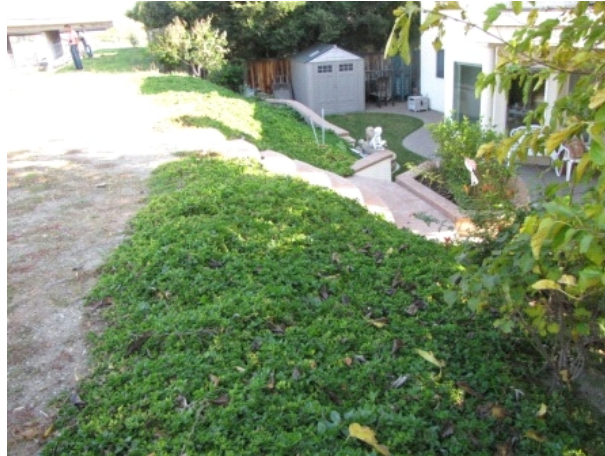
View of landscaping and irrigation on the landward slope looking upstream.

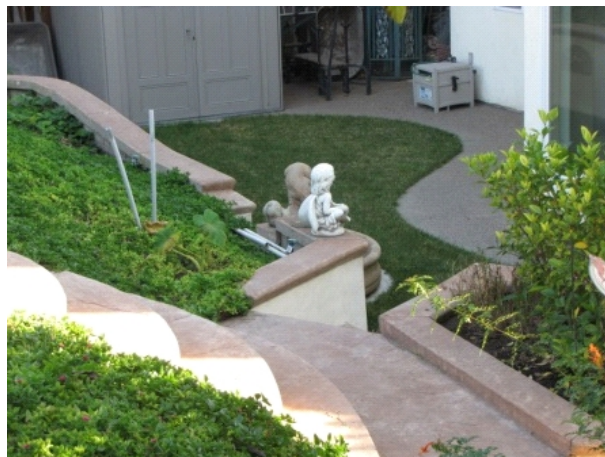
Levee Mile Report Line	35
Start Levee Mile	0.85
End Levee Mile	0.87
Location	Land Side
Category	Earthen Levee
Item	Encroachments

View of a retaining wall and patio in the landward slope.

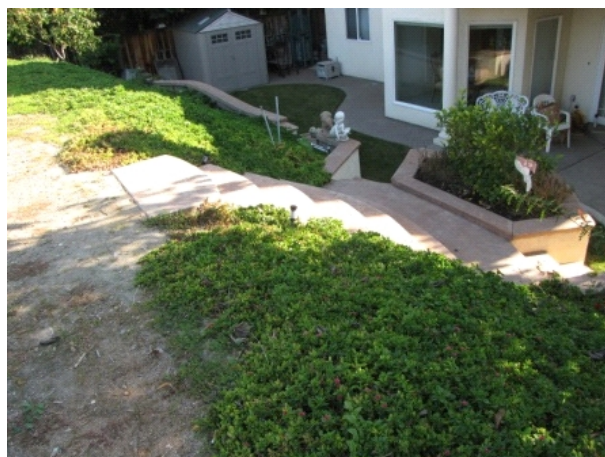
Levee Mile Report Line	36
Start Levee Mile	0.86
End Levee Mile	0.86
Location	Land Side
Category	Earthen Levee
Item	Encroachments

View of steps on the landward slope looking upstream.

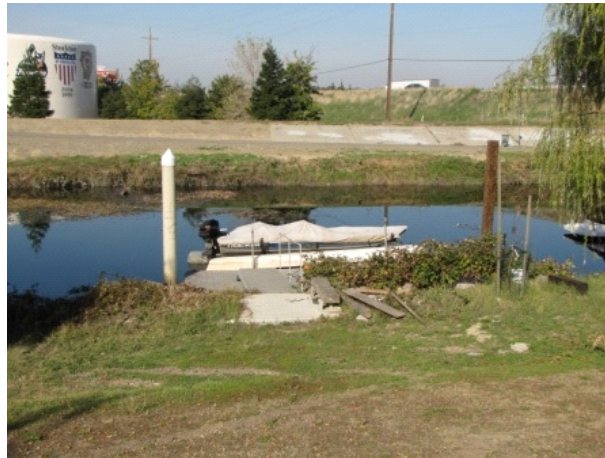
View of a dock and concrete pad on the waterward side of the berm.

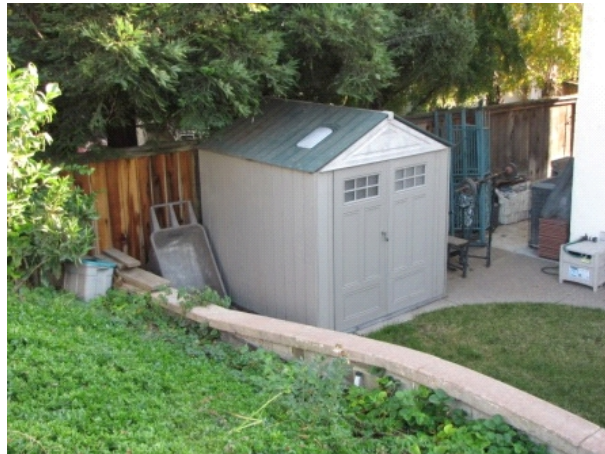
Levee Mile Report Line	38
Start Levee Mile	0.87
End Levee Mile	0.87
Location	Land Side
Category	Earthen Levee
Item	Encroachments

View of a shed located at the landward toe looking upstream.

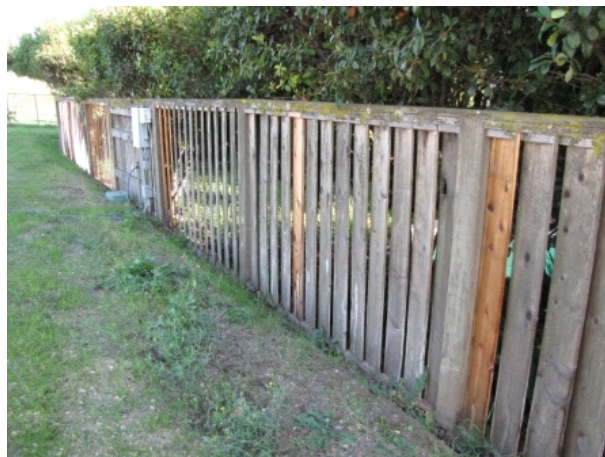
Levee Mile Report Line	39
Start Levee Mile	0.87
End Levee Mile	0.88
Location	Land Side
Category	Earthen Levee
Item	Encroachments

View of a fence at the landward shoulder blocking visibility and access looking upstream. Some encroachments can be seen through the fence but not with any detail. Also visible is an electrical panel and hose bib.

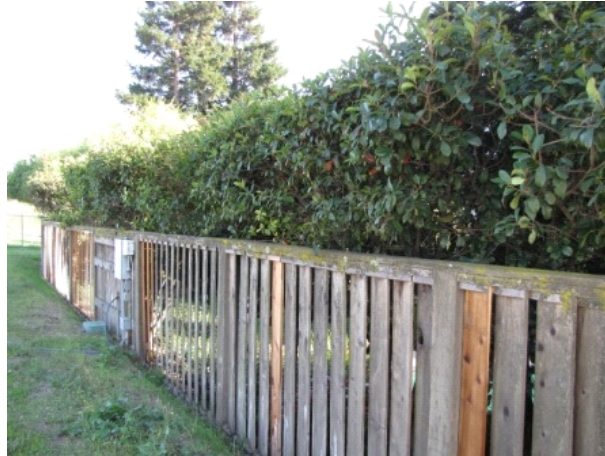
View of bushes above the fence at the landward shoulder further obstructing visibility looking upstream.

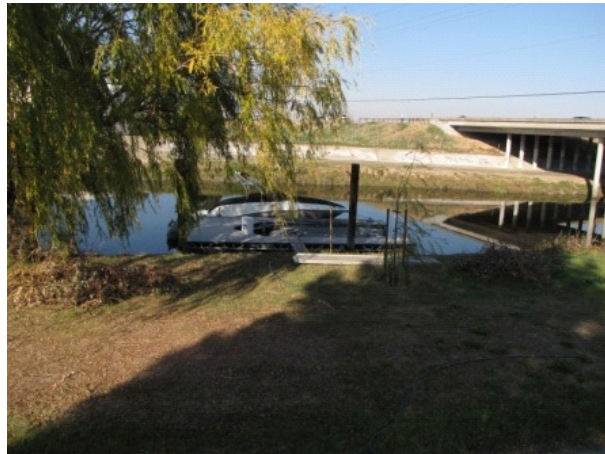
Levee Mile Report Line	41
Start Levee Mile	0.88
End Levee Mile	0.88
Location	Water Side
Category	Earthen Levee
Item	Encroachments

View of a dock on the waterward side of the berm.

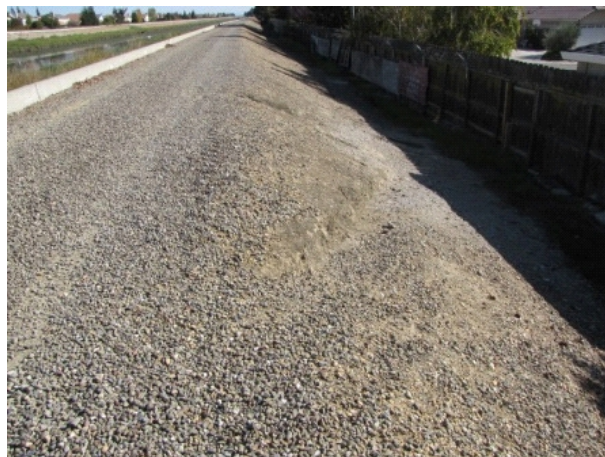
Levee Mile Report Line	42
Start Levee Mile	1.03
End Levee Mile	1.03
Location	Land Side
Category	Earthen Levee
Item	Encroachments

View of steps dug into the landward slope looking upstream.

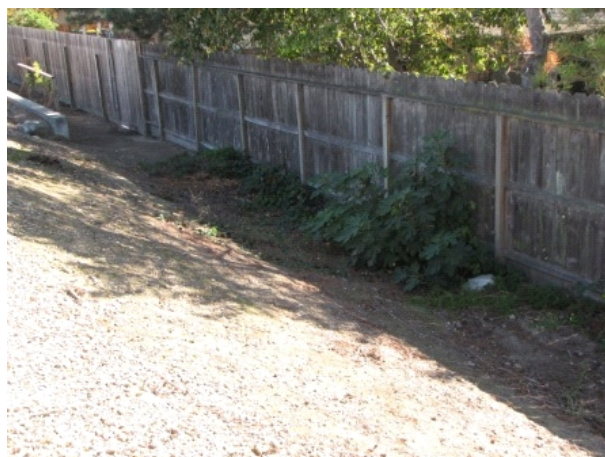
View of landowner maintained vegetation at the landward toe.

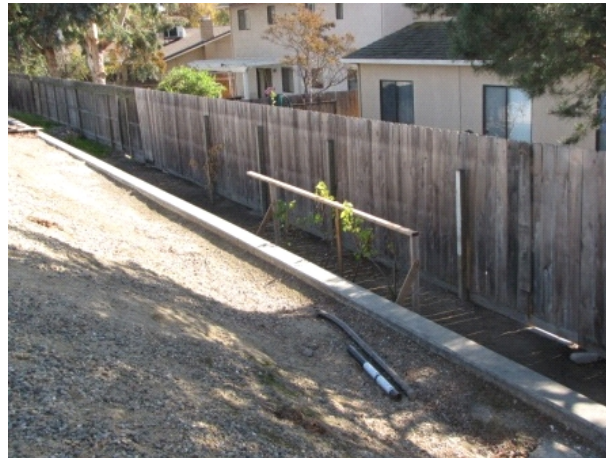
View of landowner maintained landscaping at the landward toe looking upstream.

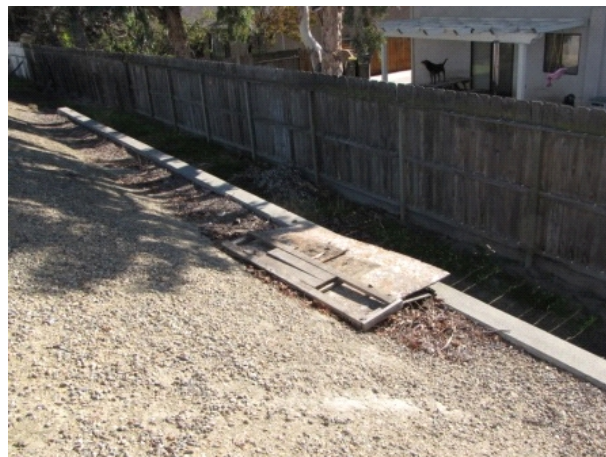
Levee Mile Report Line	48
Start Levee Mile	1.18
End Levee Mile	1.18
Location	Land Side
Category	Earthen Levee
Item	Encroachments

View of debris on the landward slope.

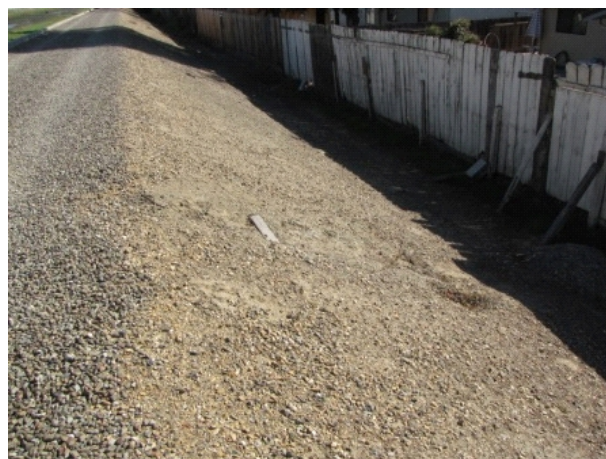
Levee Mile Report Line	50
Start Levee Mile	1.20
End Levee Mile	1.20
Location	Land Side
Category	Earthen Levee
Item	Encroachments

View of steps dug into the landward slope looking upstream.

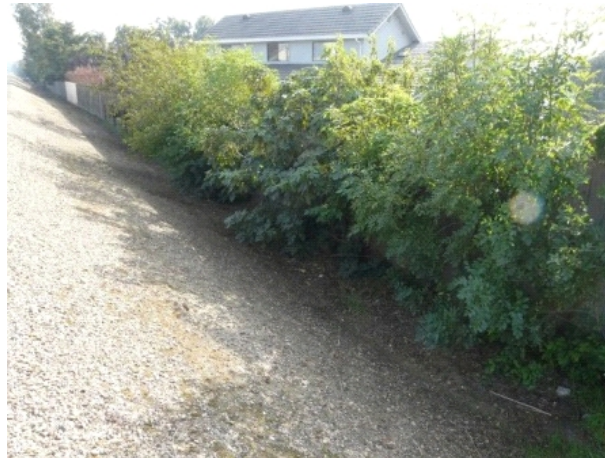
Levee Mile Report Line	51
Start Levee Mile	1.27
End Levee Mile	1.27
Location	Land Side
Category	Earthen Levee
Item	Vegetation
Landscaping along landside toe of levee at LM 1.27	
dpesaven_20091022_79.JPG

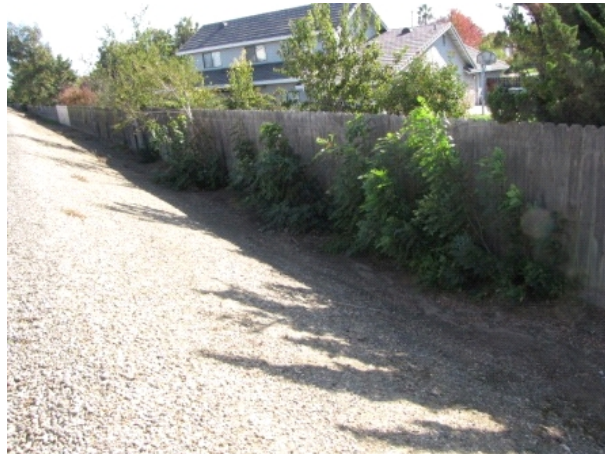
Levee Mile Report Line	51
Start Levee Mile	1.27
End Levee Mile	1.27
Location	Land Side
Category	Earthen Levee
Item	Vegetation
Updated view of vegetation along the landward toe as of fall 2009.	
dpesaven_20091124_552.jpg

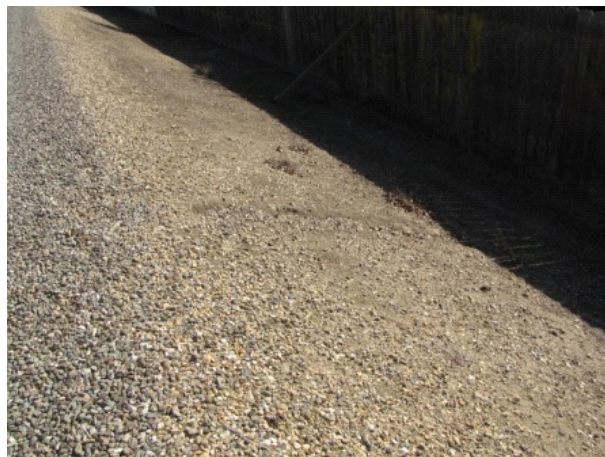
Levee Mile Report Line	52
Start Levee Mile	1.29
End Levee Mile	1.29
Location	Land Side
Category	Earthen Levee
Item	Encroachments
View of steps dug into the landward slope looking upstream.	
dpesaven_20091124_553.jpg

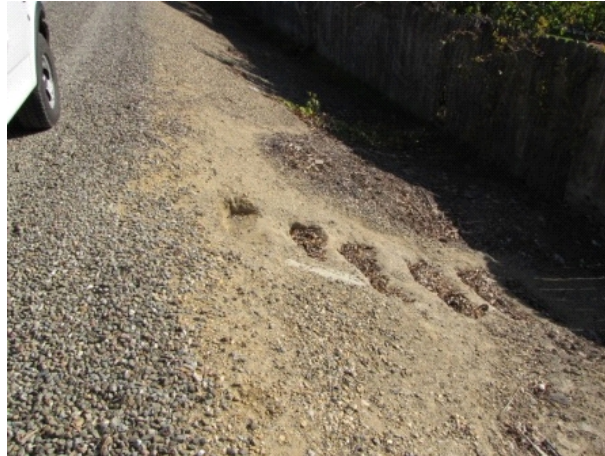
View of steps dug into the landward slope looking upstream.

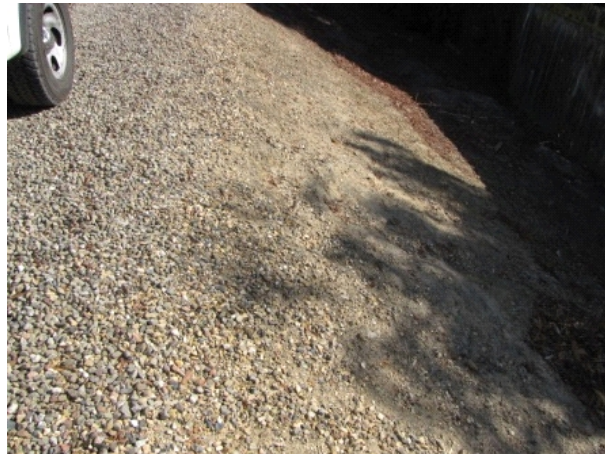
Levee Mile Report Line	54
Start Levee Mile	1.36
End Levee Mile	1.36
Location	Land Side
Category	Earthen Levee
Item	Encroachments

View of steps dug into the landward slope looking upstream.

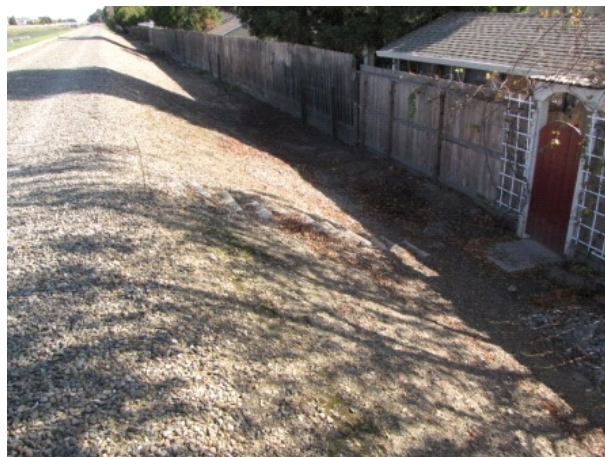
Levee Mile Report Line	55
Start Levee Mile	1.39
End Levee Mile	1.39
Location	Land Side
Category	Earthen Levee
Item	Encroachments

View of steps dug into the landward slope looking upstream.

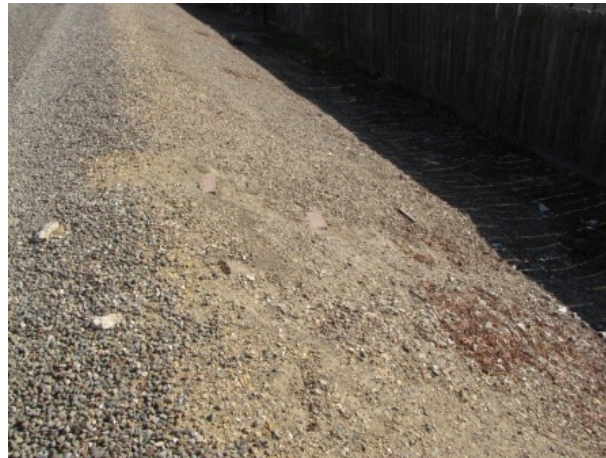
View of steps dug into the landward slope looking upstream.

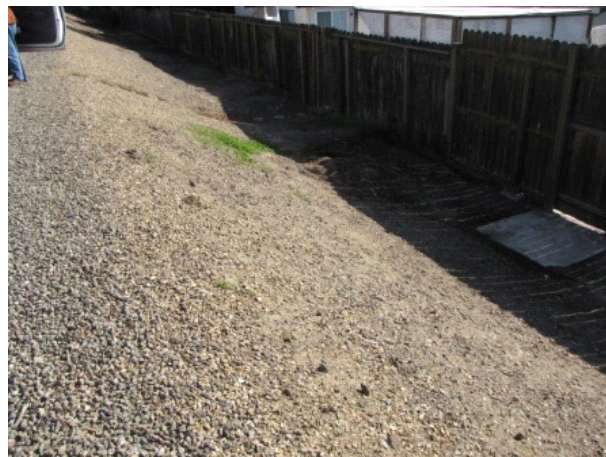
Levee Mile Report Line	57
Start Levee Mile	1.44
End Levee Mile	1.44
Location	Land Side
Category	Earthen Levee
Item	Slope Stability

View of a concrete pad at the landward toe cut into the slope.

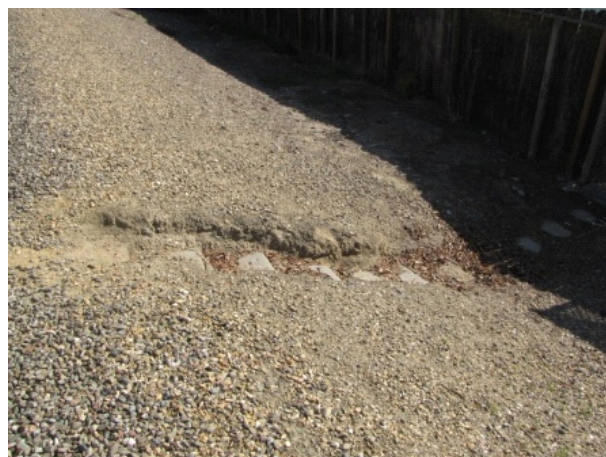
Levee Mile Report Line	58
Start Levee Mile	1.45
End Levee Mile	1.45
Location	Land Side
Category	Earthen Levee
Item	Encroachments

View of steps dug into the landward slope looking upstream.

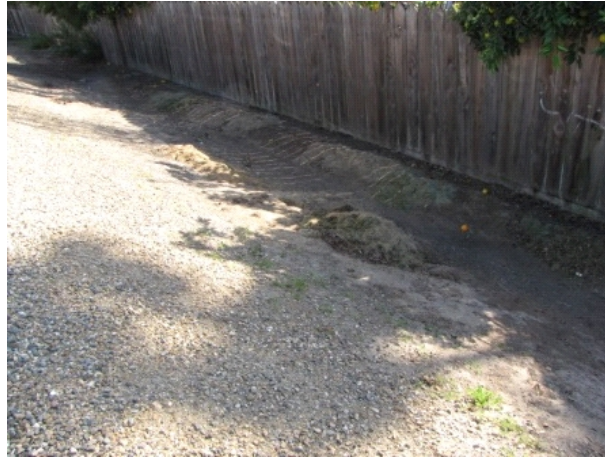
View of lawn clippings placed at the landward toe.

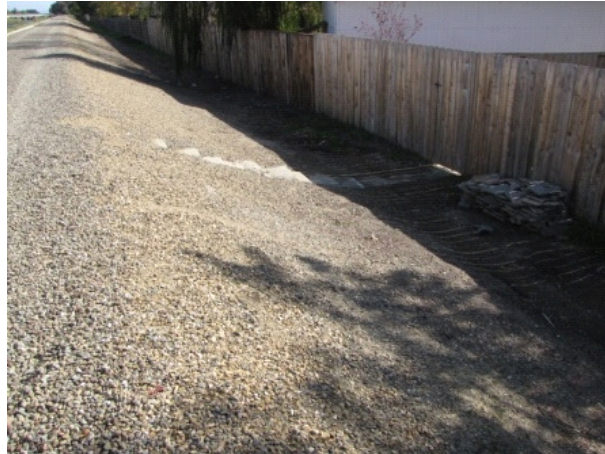
Levee Mile Report Line	61
Start Levee Mile	1.51
End Levee Mile	1.51
Location	Land Side
Category	Earthen Levee
Item	Encroachments

View of steps dug into the landward slope looking upstream.

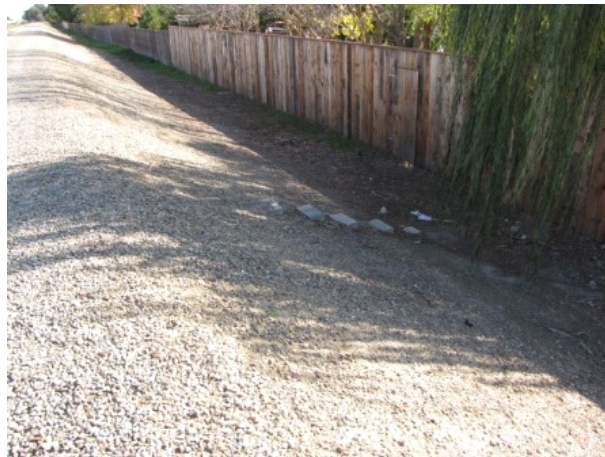
Levee Mile Report Line	62
Start Levee Mile	1.52
End Levee Mile	1.52
Location	Land Side
Category	Earthen Levee
Item	Encroachments

View of steps dug into the landward slope looking upstream.

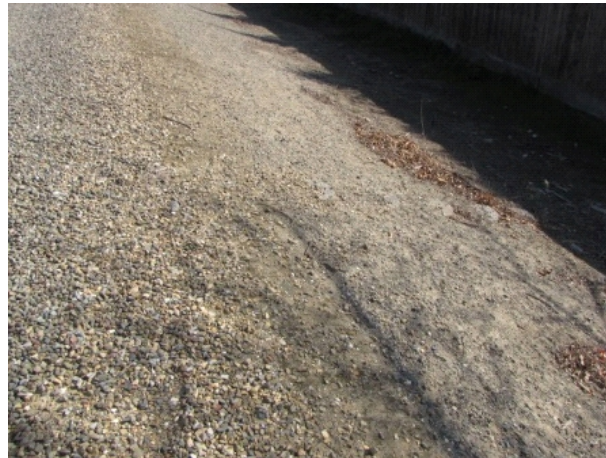
View of steps dug into the landward slope looking upstream.
